ECCLESIASTICAL ARCHITECTURE IN THE FORTIFICATIONS OF ARMENIAN CILICIA: SECOND REPORT

ROBERT W. EDWARDS

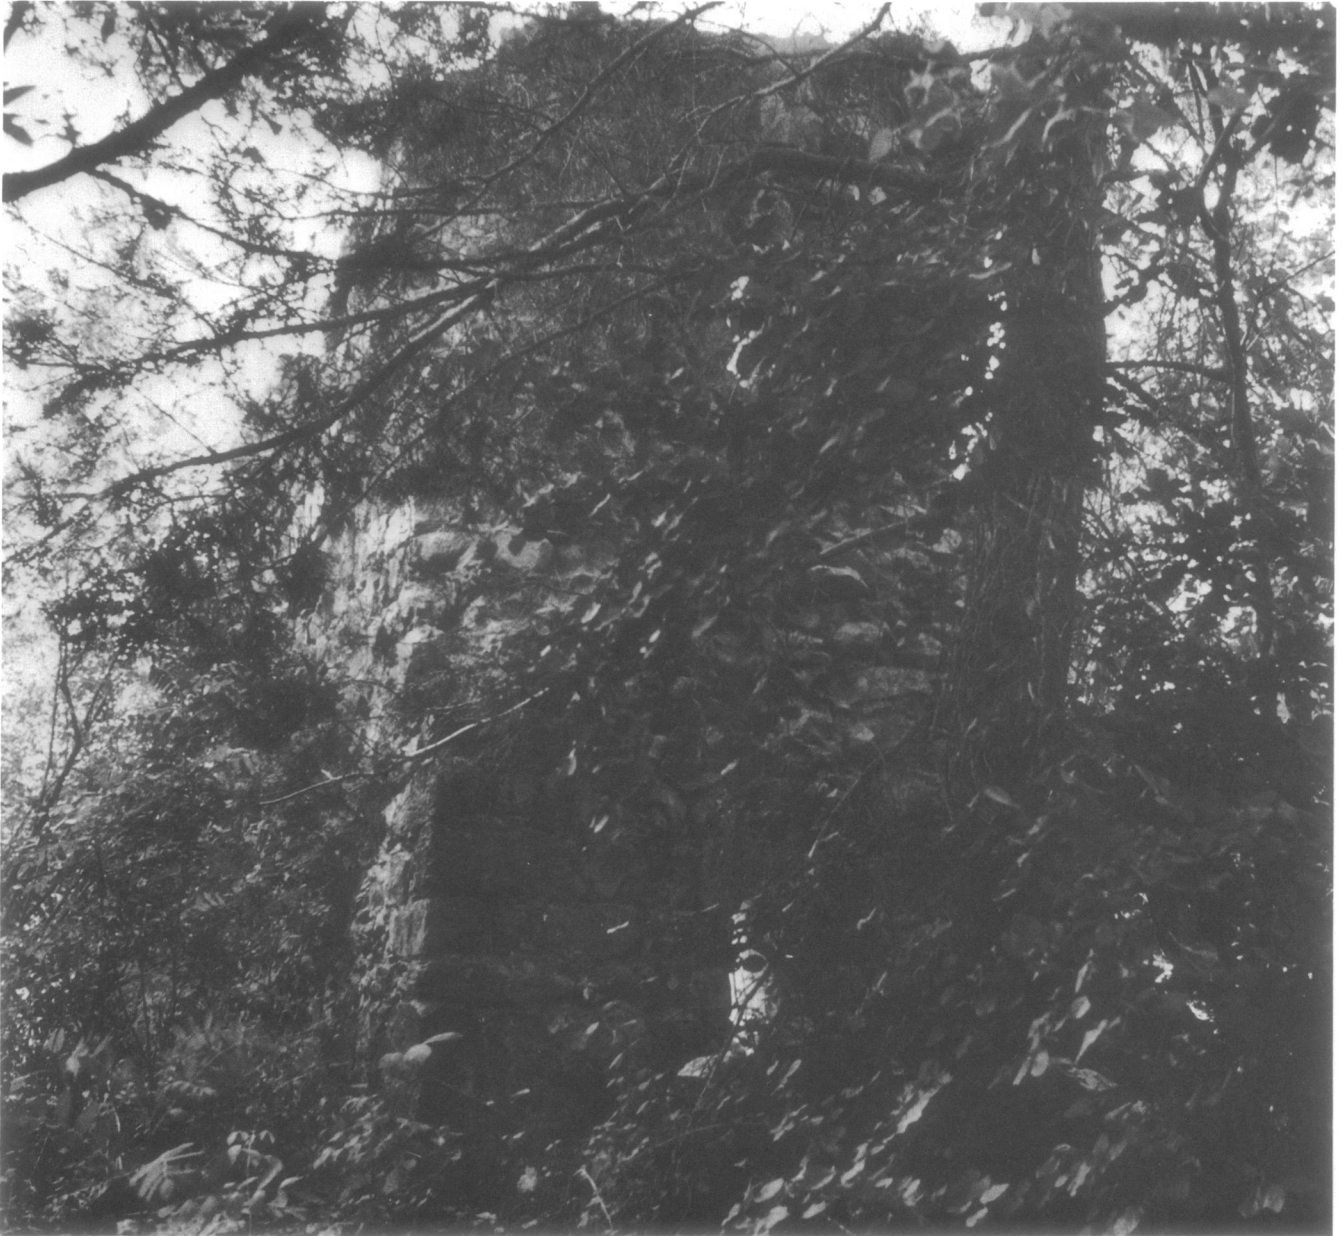
1. Frenk, Church, Exterior, looking West at the Southeast Corner

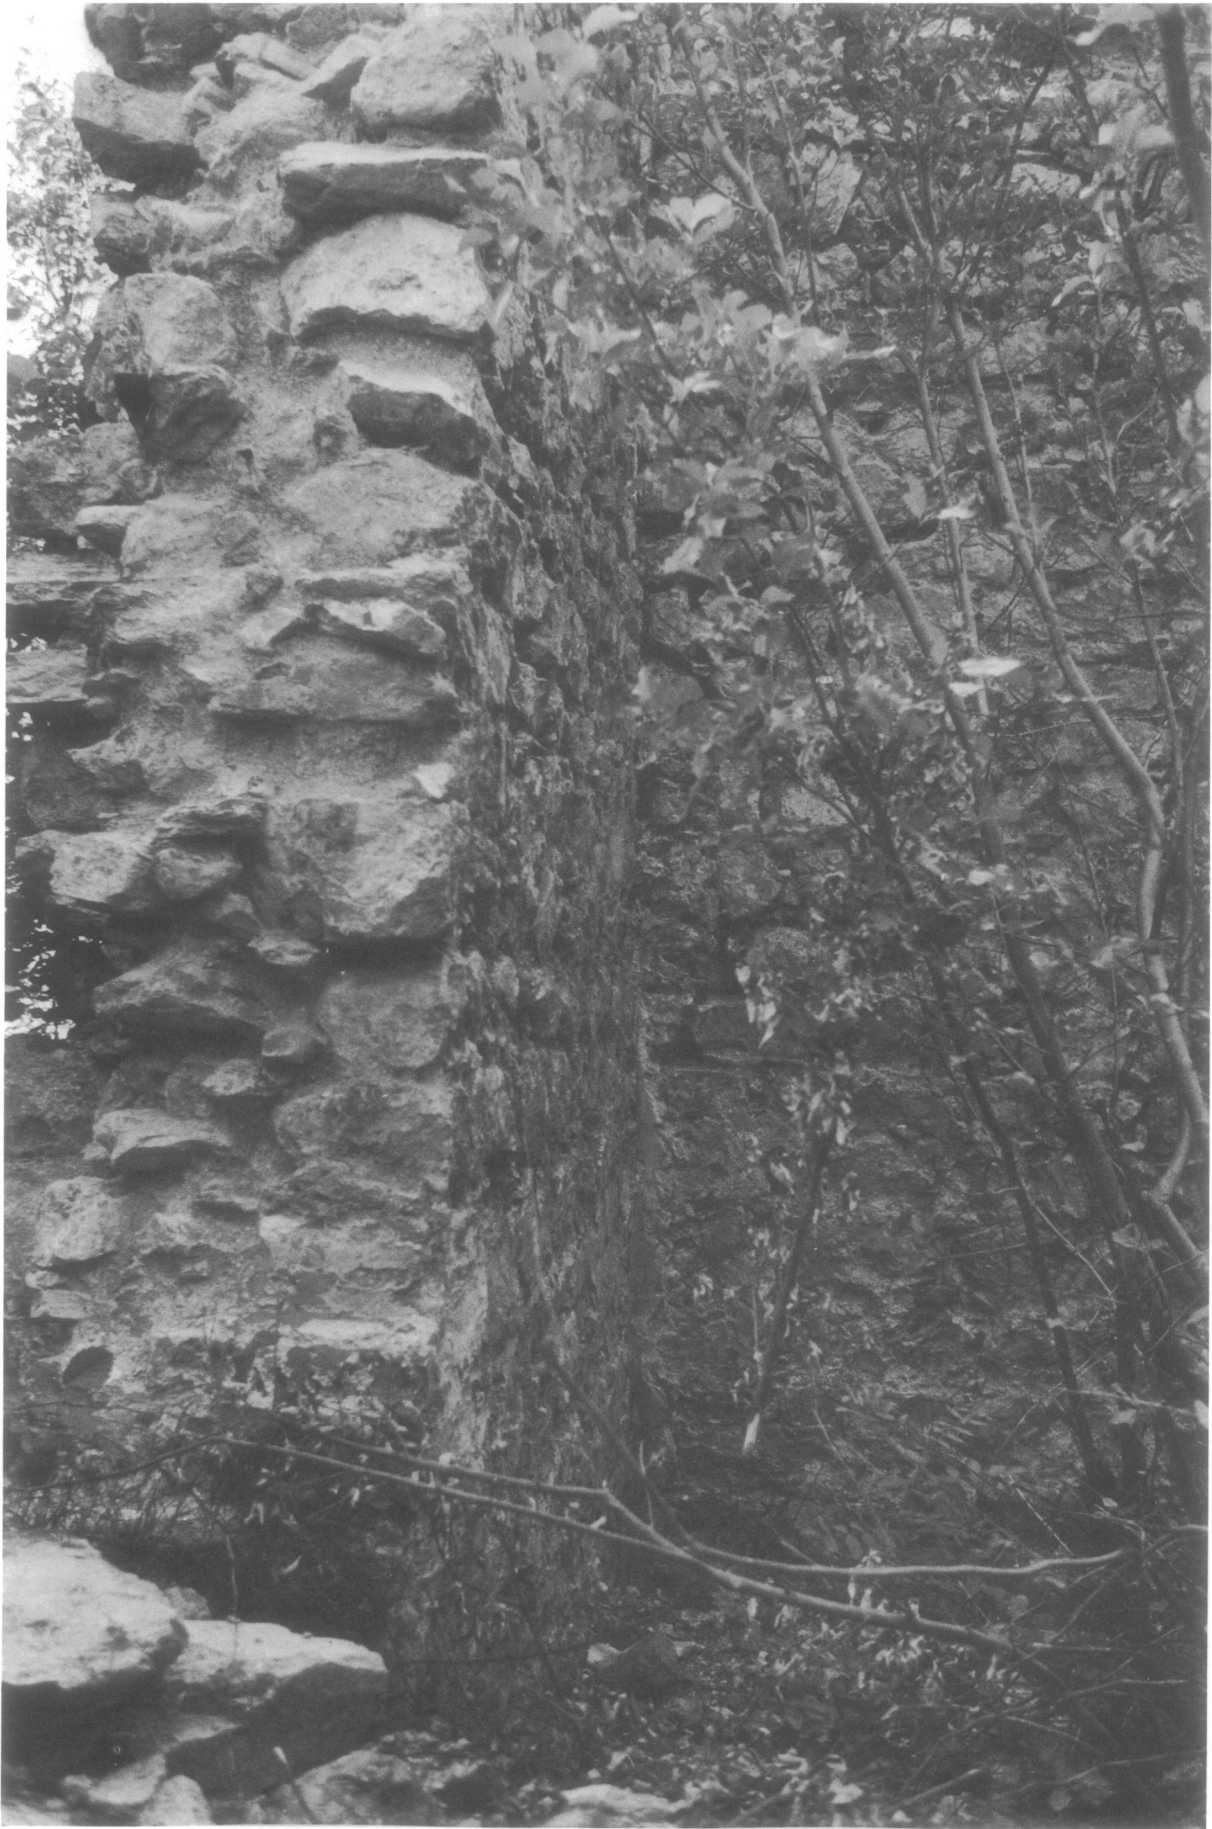
3. Frenk, Church, Interior, looking Southwest into Southwest Corner of Nave

It is possible that in the present breach in the south wall of the nave there was once a door (fig. 3), but there is no evidence in the debris to confirm this. There is evidence that a door once opened in the west wall. This door was covered by a rounded vault and was not aligned to the central apse. A window with a slight splay surmounted it. The only area of the church where I found fragments of brick was in the core of the wall which had been exposed by the collapse of the west door. The nature of the covering over the nave cannot be determined. If the church of the Constable Smbat had a central dome, then this is equally possible here.

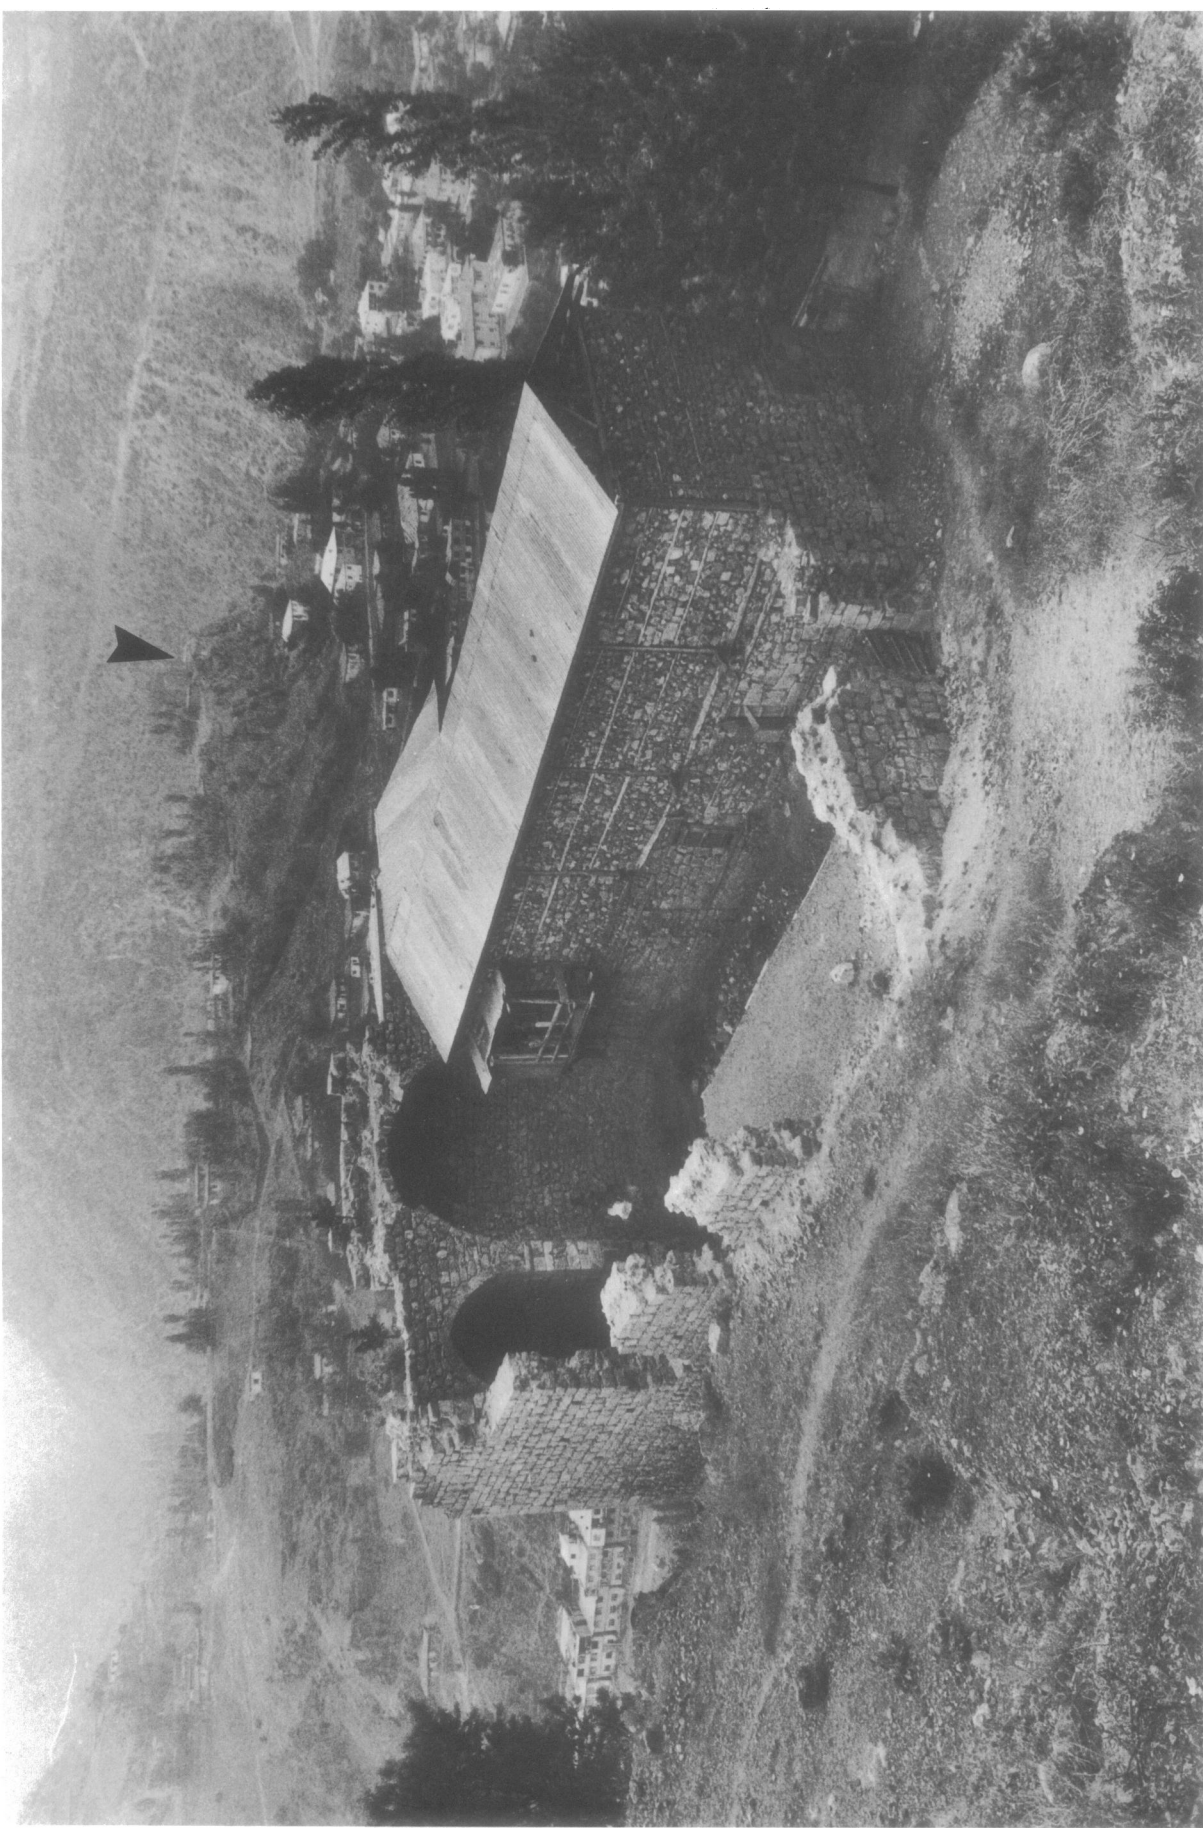
10. Saimbeyli, Church of St. James, Exterior, looking Southeast; Arrow Shows Location of Fort

When approaching the village of Saimbeyli (Armenian: Haçin) from the south, the medieval fortress is clearly visible on the right flank of the road (fig. 10, as indicated by the arrow).²⁹ The fortress wall surrounds the southern end of an oblong outcrop. The modern town of Saimbeyli is on the west side of this outcrop. The chapel is lodged in the east circuit wall and from the exterior it appears to be just another tower (figs. 30–31). The chapel is damaged severely; only the foundation of the nave is visible today (figs. 32–33). Fortunately, the apse is still standing.

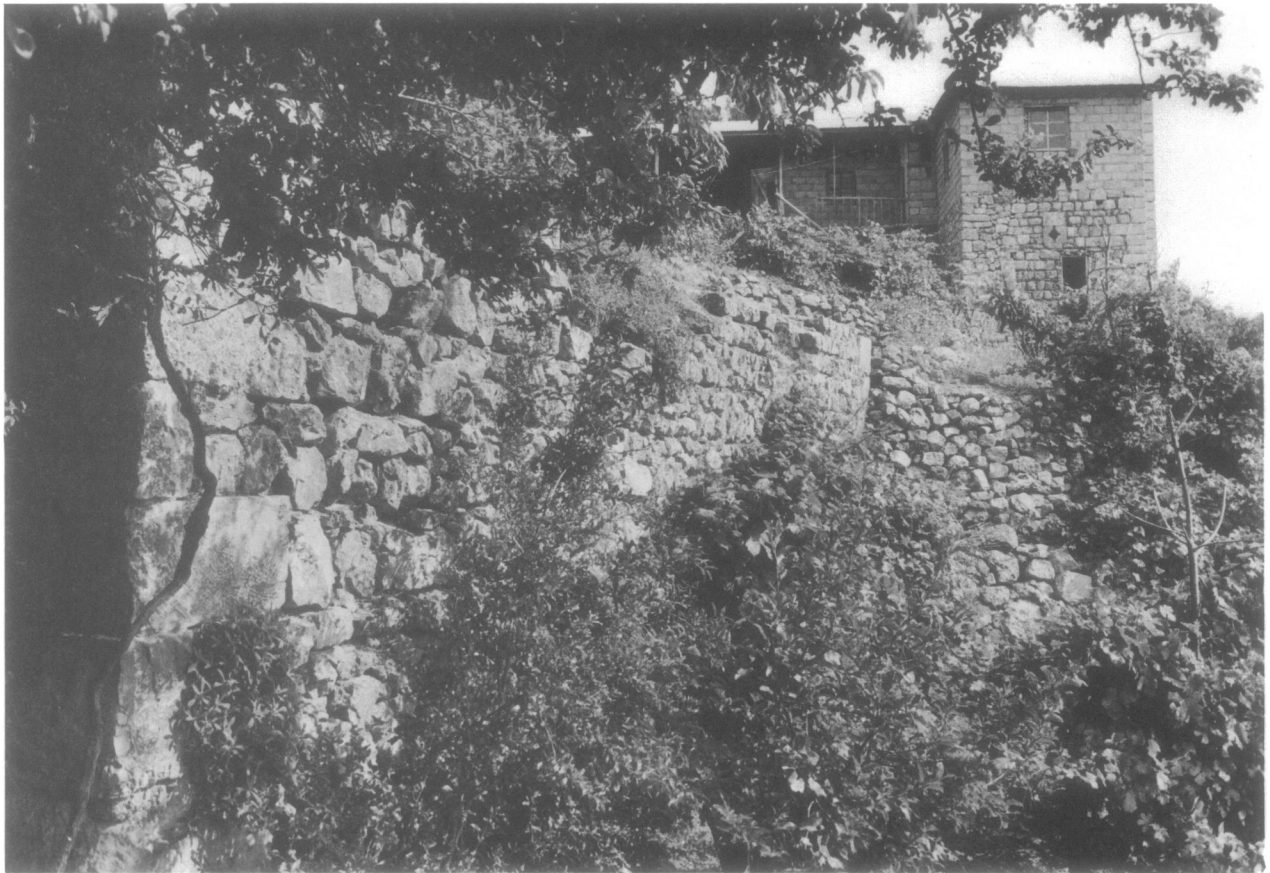
11. Looking North at Circuit Wall (foreground) and South Apsidole (background, right)

In 1981 little was left of the monastery except for a font, the foundation of an orphanage school, and fragments of a once huge circuit wall that surrounded the complex (fig. 11). The church of St. James occupies the northeast corner of the monastery. In its present state it is the largest extant Armenian church in Cilicia. The entire ceiling of the church as well as large sections of the north, west, and south walls have collapsed (fig. 10). In its undamaged state this hall church was divided longitudinally into a nave and two aisles; it was cov-

At the southeast corner a square room is attached to the south wall of the south apsidiole (fig. 11). The door in the west wall of this room, unlike the window in its south wall, appears to be part of the original construction. What remains of the south wall of the church has been repaired on a number of occasions, but there are indications of at least one door opening into the south aisle. The photograph of the church taken in the early twentieth century (fig. 12) shows that there was a high-level window at each end of the south wall. It is also quite possible that there is a vaulted south entrance into the narthex. The circuit wall, which at one time surrounded the monastery, probably attached to the church at the southeast corner (fig. 11). The masonry of the circuit wall is fairly crude, except for its quoins which are similar to those in the church.

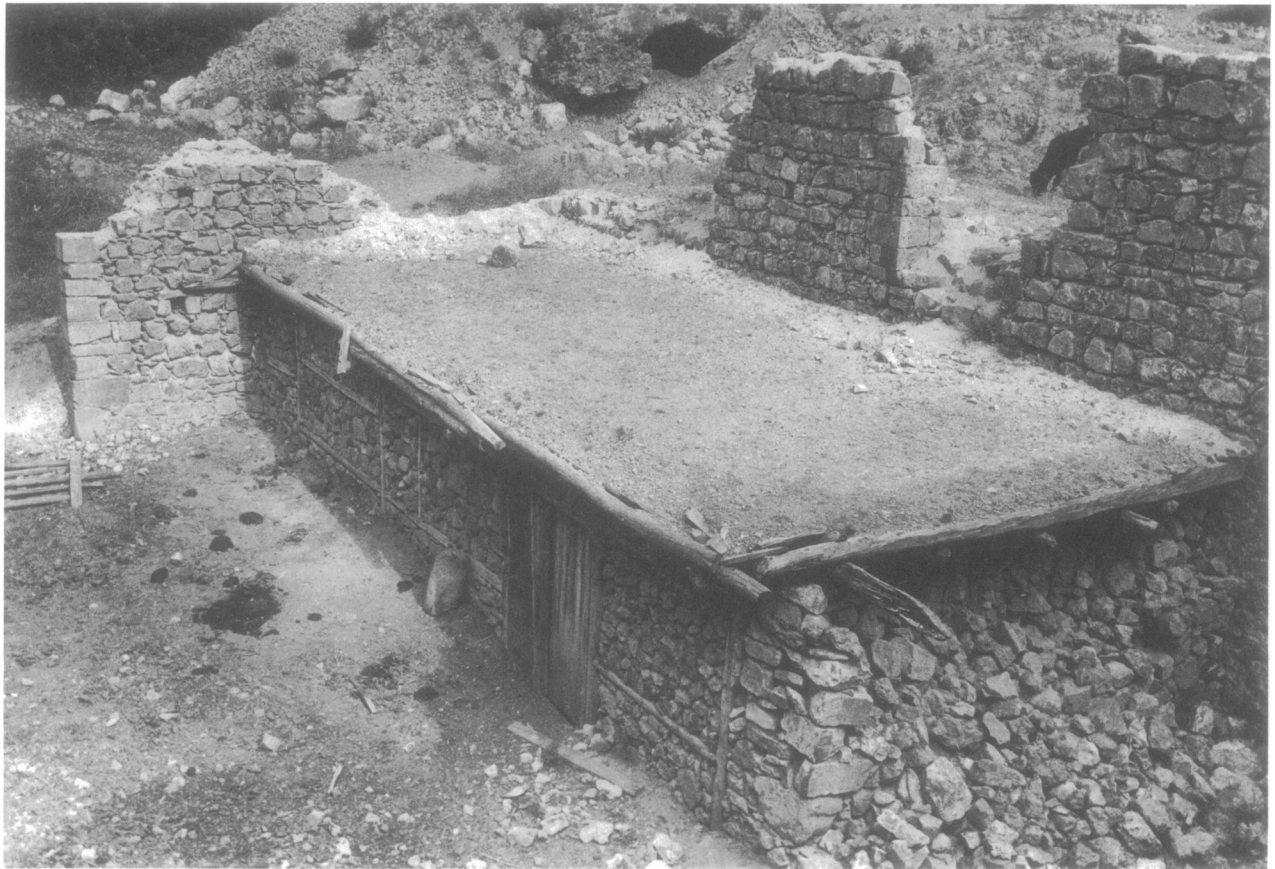
15. Looking Northwest at Nave

Because of extensive damage, the exact interior plan of the church is impossible to determine. A barn with a dirt roof was constructed recently in the northwest corner of the nave (fig. 15). The beams which support the roof of the barn actually are anchored in the joist holes which once supported the one-story wooden gallery over the aisle. Just above the roof of the barn are the remains of

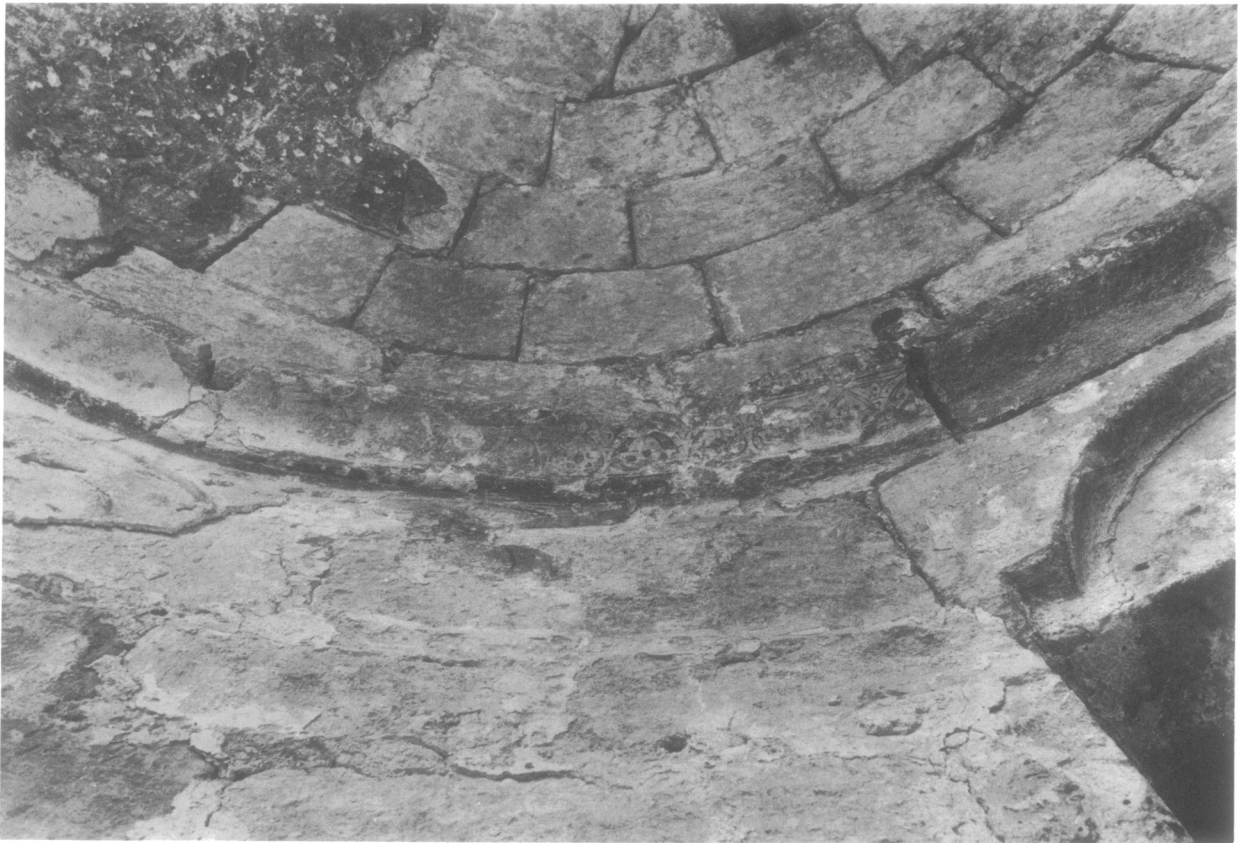
29. Looking Northeast at Cornice Molding of Central Apse

Since my first visit in 1973 the deterioration of the painted plaster in the central apse has become noticeable. In 1981 the delicate foliage on the underside of the congé molding was visible only in a small area (fig. 29).

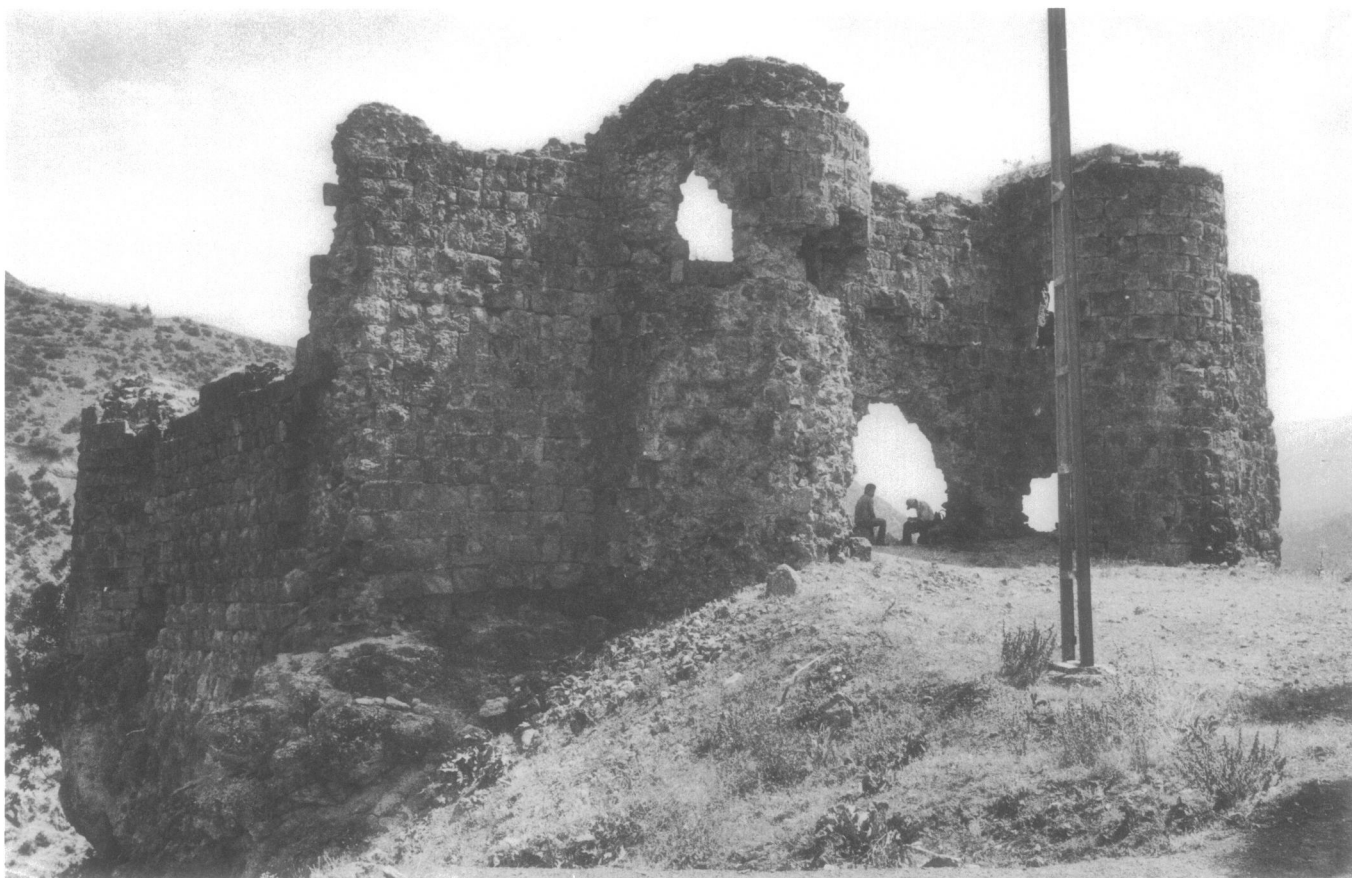
31. Exterior, looking South at Chapel C (far left), and Towers A and B

Because of its condition the chapel is difficult to evaluate in terms of masonry. On the exterior of the apse there are regular courses of well-cut rusticated ashlar with drafted margins (fig. 31). On

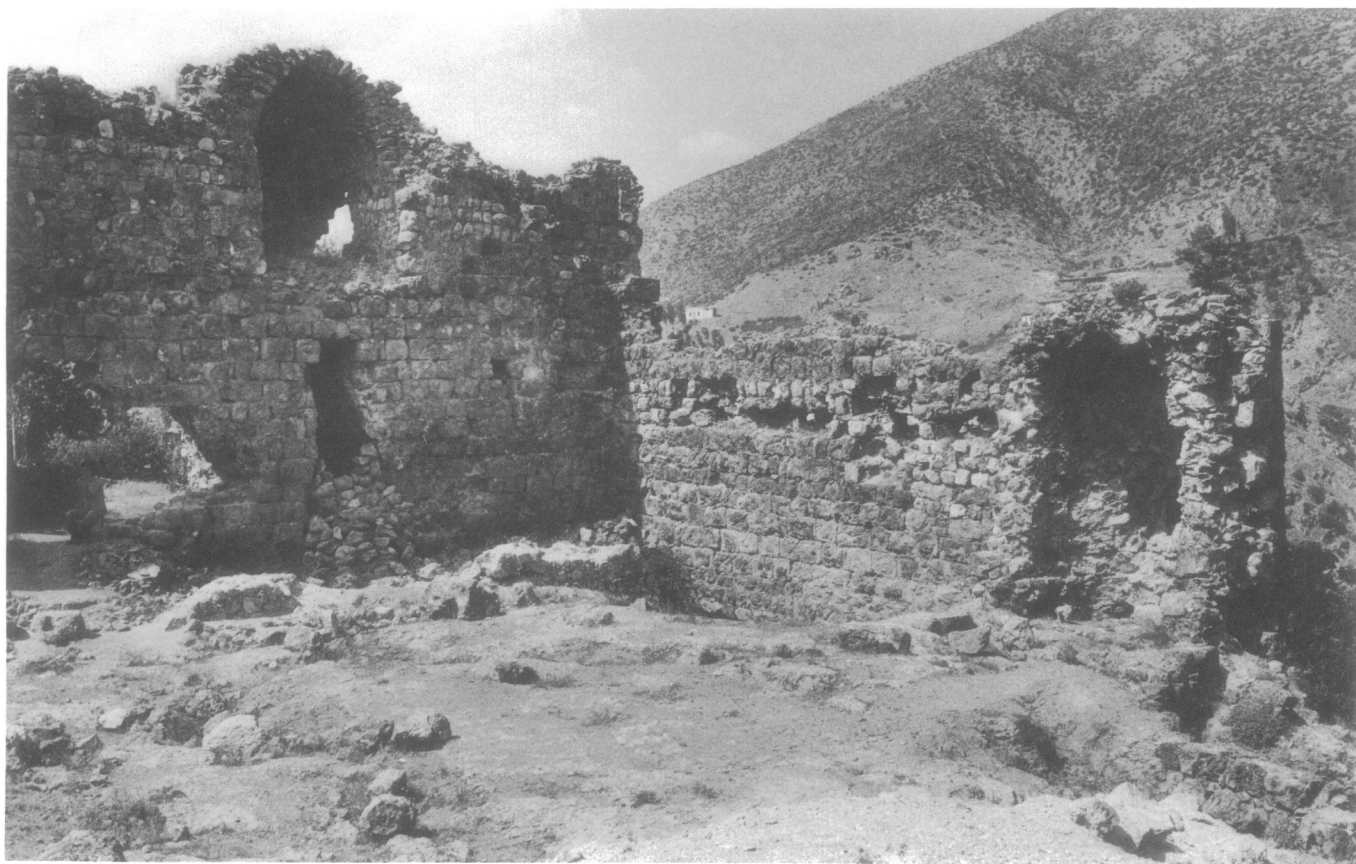
32. Interior, looking North at Chapel C (right)

It seems quite probable that the chapel (or at least its apse) was in use after the fall of the Armenian kingdom. Sometime in the first half of the fifteenth century the abandoned fort was converted into a cloister. Most of the north half of the fort's enclosure was occupied by the church of the Holy Mother of God and other buildings.³¹ The rectangular area adjoining the west end of the chapel (H on fig. 30) is probably the rough outline of the church. Today only the foundation of the church survives (figs. 32

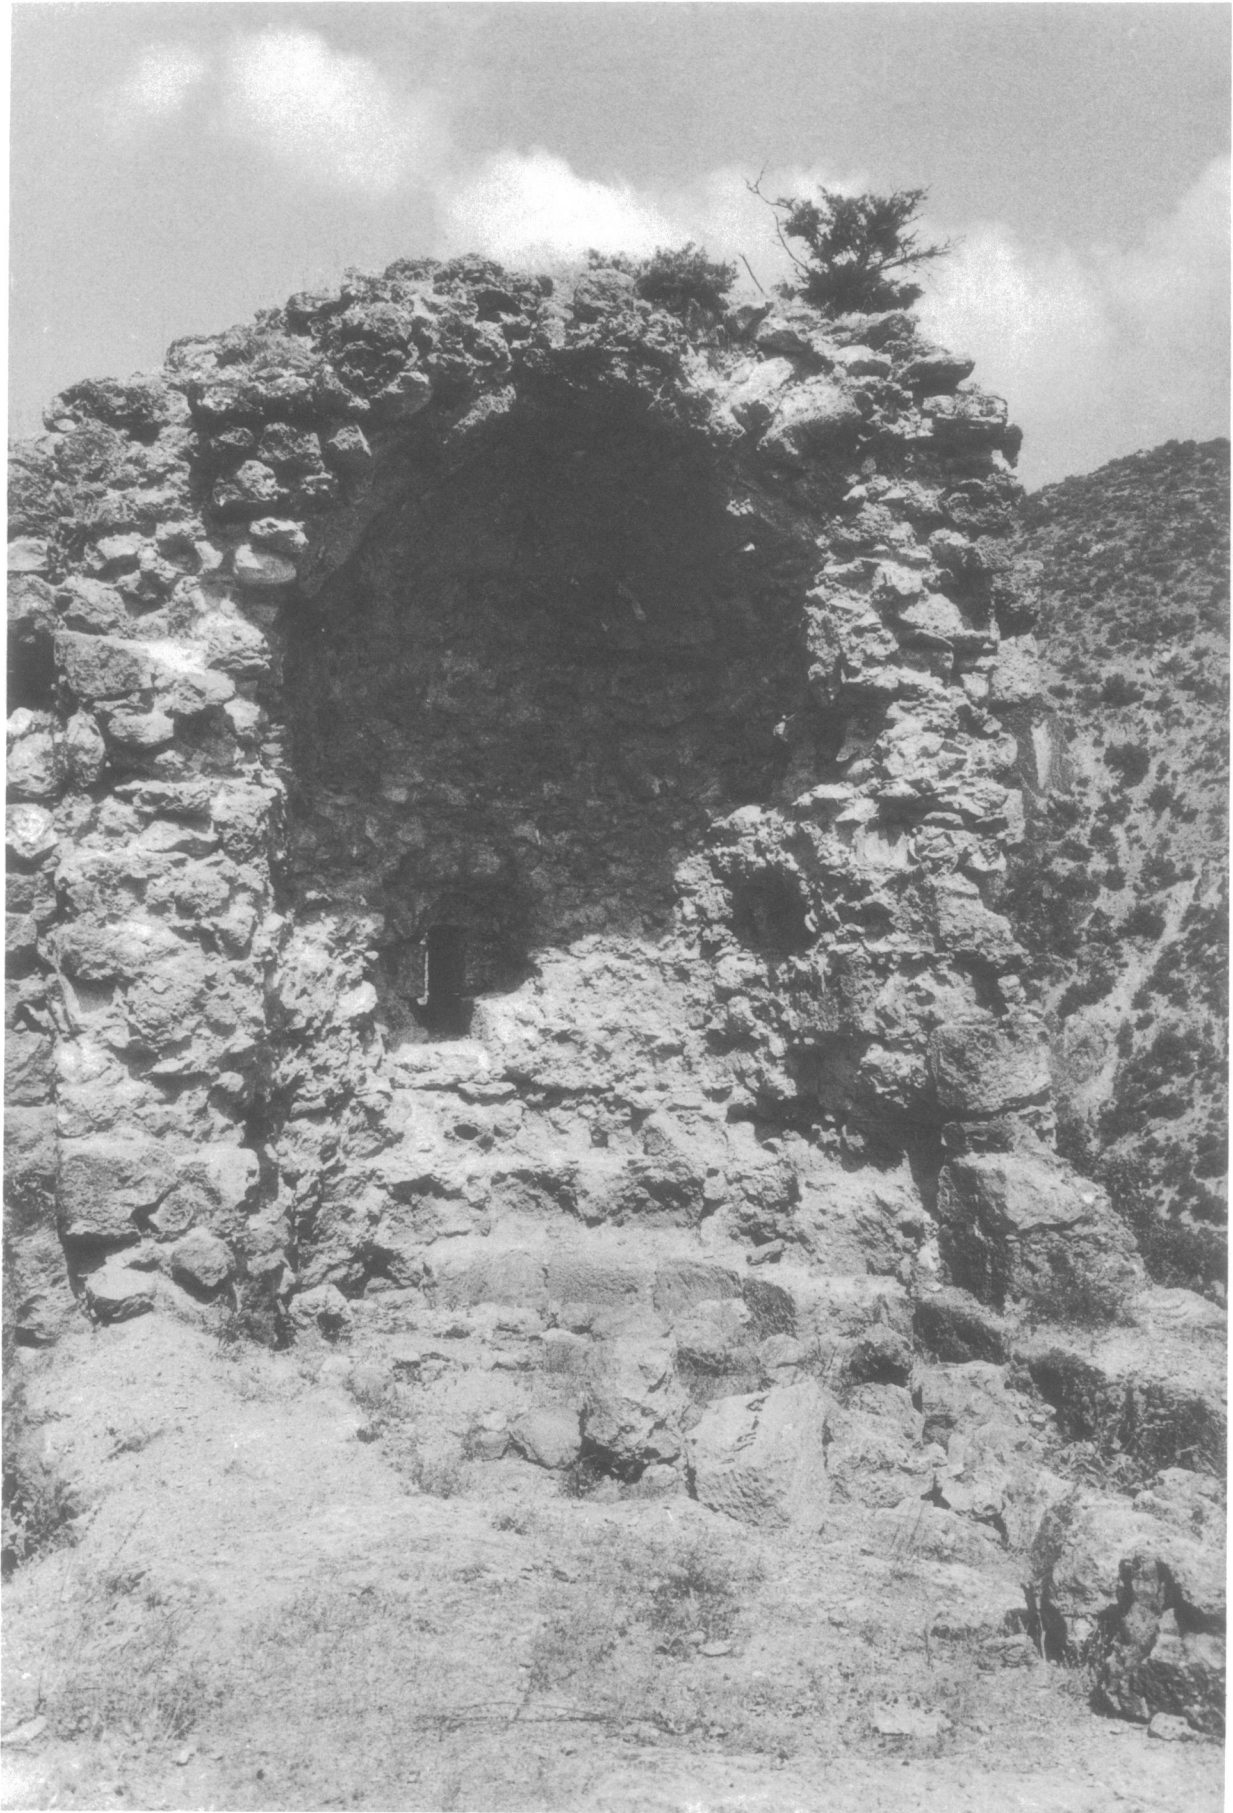
33. Saimbeyli, Fortress, Interior, looking East into Chapel C

Only excavations can determine the position and number of doors in the nave. On the interior there are narrow ledges near the base of the nave walls (figs. 2 and 33). Their significance is unknown. There is no indication that a ledge continues around the apsidal wall. The location and number of niches in the apse can never be determined because of existing damage. The frame for the embrasured window in the center of the apse survives only on the exterior.

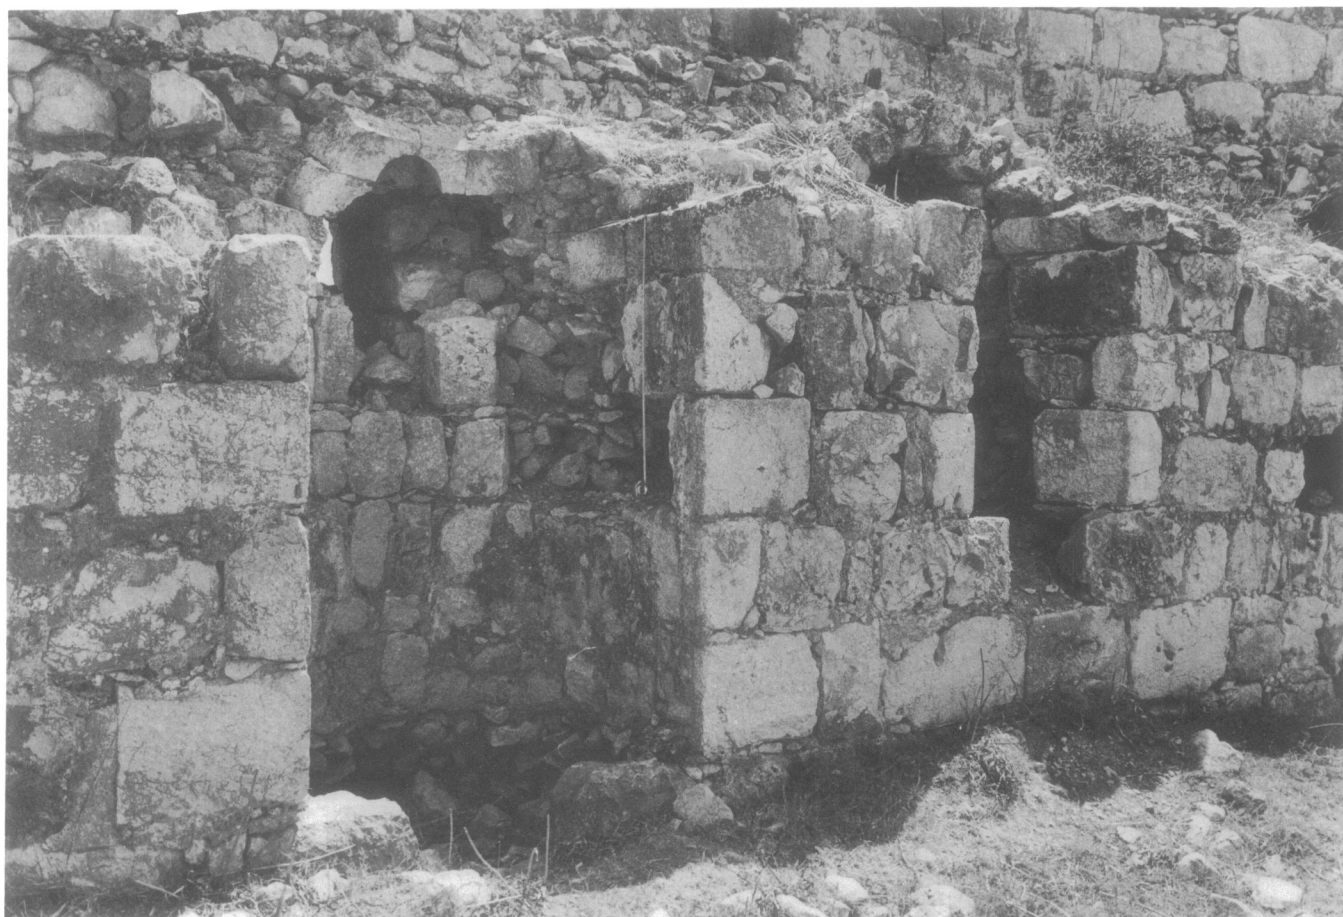
36. Parapet Chapel, Interior, looking East

The diameter of the apse is 145 cm. and its depth is 130 cm. The apse is pierced in the center by an embrasured window and is flanked by two low-level squareheaded niches (figs. 36–37). The niche at the north is 44 cm. in width. The south niche is badly damaged. The interior sides of both niches have been removed. It appears that the floor of the apse was fully excavated some years ago by treasure hunters. This digging exposed a socle of rather crude stones. At the level of the socle large ashlar blocks extend from the ends of the apsidal walls to mark the limit of the apse. These blocks probably formed a continuous step and the present gap in the center is merely an indication of a missing block, not a doorway. Since this step is higher than the present ground level, the floor of the apse suggests a bema. Even with the bema, the floor level of the

The most interesting feature found in the apse is that the apsidal window protrudes into the space of the semidome (figs. 36–37). Fragments of the windowsill are still *in situ* and show that the original interior height of the opening was 106 cm. The sill typically slants downward to the west. The depth of the window is 128 cm. In the south wall of the apse the first row of springing stones for the apsidal vault is still *in situ*. At first glance these springing stones seem oversized in comparison to the other remaining stones of the semidome. But this is not unusual when one compares them to their counterparts in the central apse of the church of T'oros I.³⁸ The quality of the ashlar in the semidome of the parapet chapel is also comparable to the neighboring church.³⁹ There is no cornice molding to separate the collapsed semidome from the apsidal wall. Such a decoration would have been broken by the intervening window. The Armenians probably adapted their constructions here to include the original window openings of the Byzantine east circuit. They could enlarge or contract the size of the window depending on the purpose of the adjoining structure; but what the Armenian builders could not do in the chapel was to raise the height of the semidome, for then the now collapsed wall walk behind the crenellations would have been cut off (fig. 37). The wall walk once rested on the semidome and on the barrel vaults of the flanking *archière* chambers.

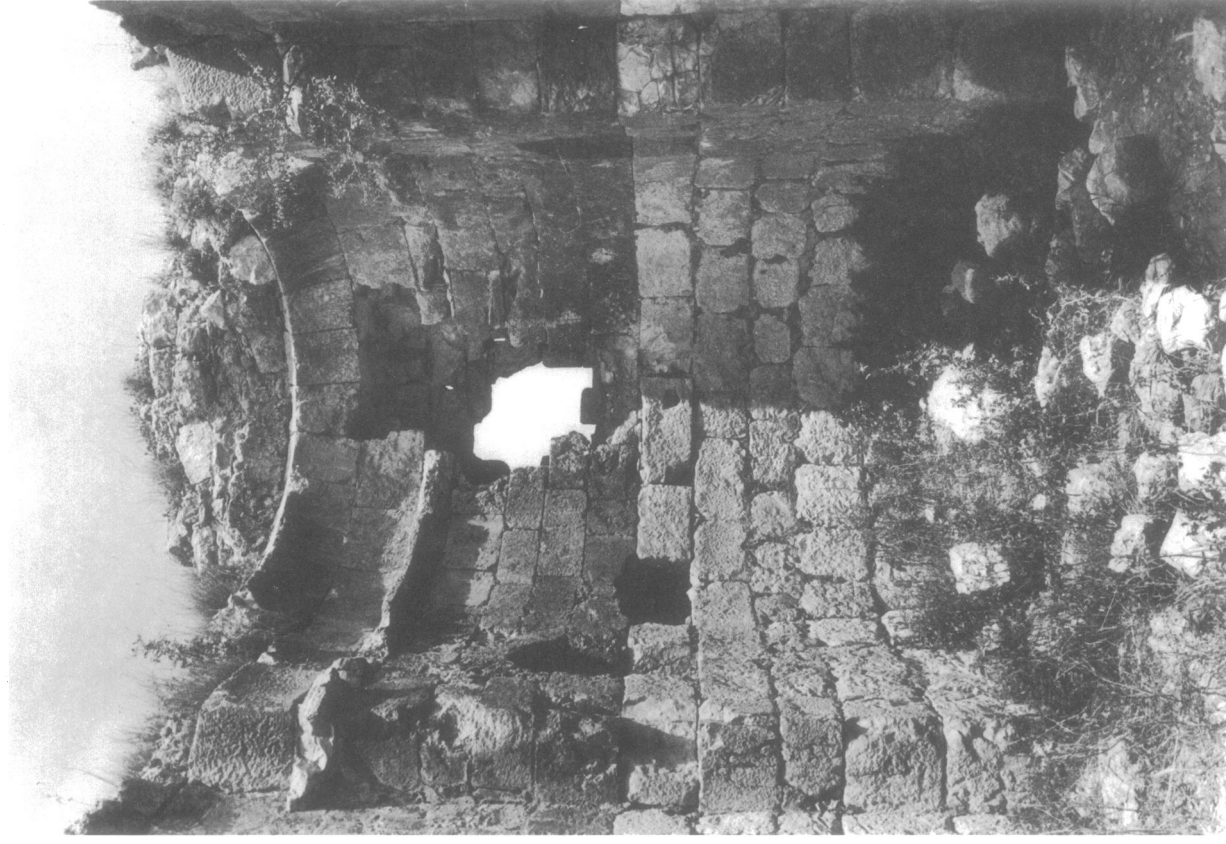
44. Looking East into Apse

(fig. 44) and has a monolithic base, now broken, which has been hollowed out into a dish. This is similar to the corresponding niche at Çardak, although in the latter the niche base has a drainage hole and a protruding scallop decoration. Here at Anavarza the area opposite the north niche in the south wall does not have a compartment, but a large hole in the south wall may once have held a niche (fig. 2).

The only area of this chapel that has deteriorated since my first visit in 1973 is the apse (fig. 44). At that time more of the apsidal vault was standing. Today most of the first two courses of the semidome are *in situ*. The ashlar of the semidome is of very high quality with narrow margins. What I had earlier thought to be fragments of painted stucco on the semidome, on closer examination turned out to be traces of a deteriorating core which was oozing through the interstices of the facing stones. It is quite possible that the entire apse, as well as the nave, was left undecorated. A very handsome tapered molding, which boldly projects more than 19 cm., separates the apsidal wall from the semidome. In the apsidal wall two round-headed niches flank the window. The sill of the window, which is still *in situ*, clearly indicates that this embrasured opening was angled slightly to the south.

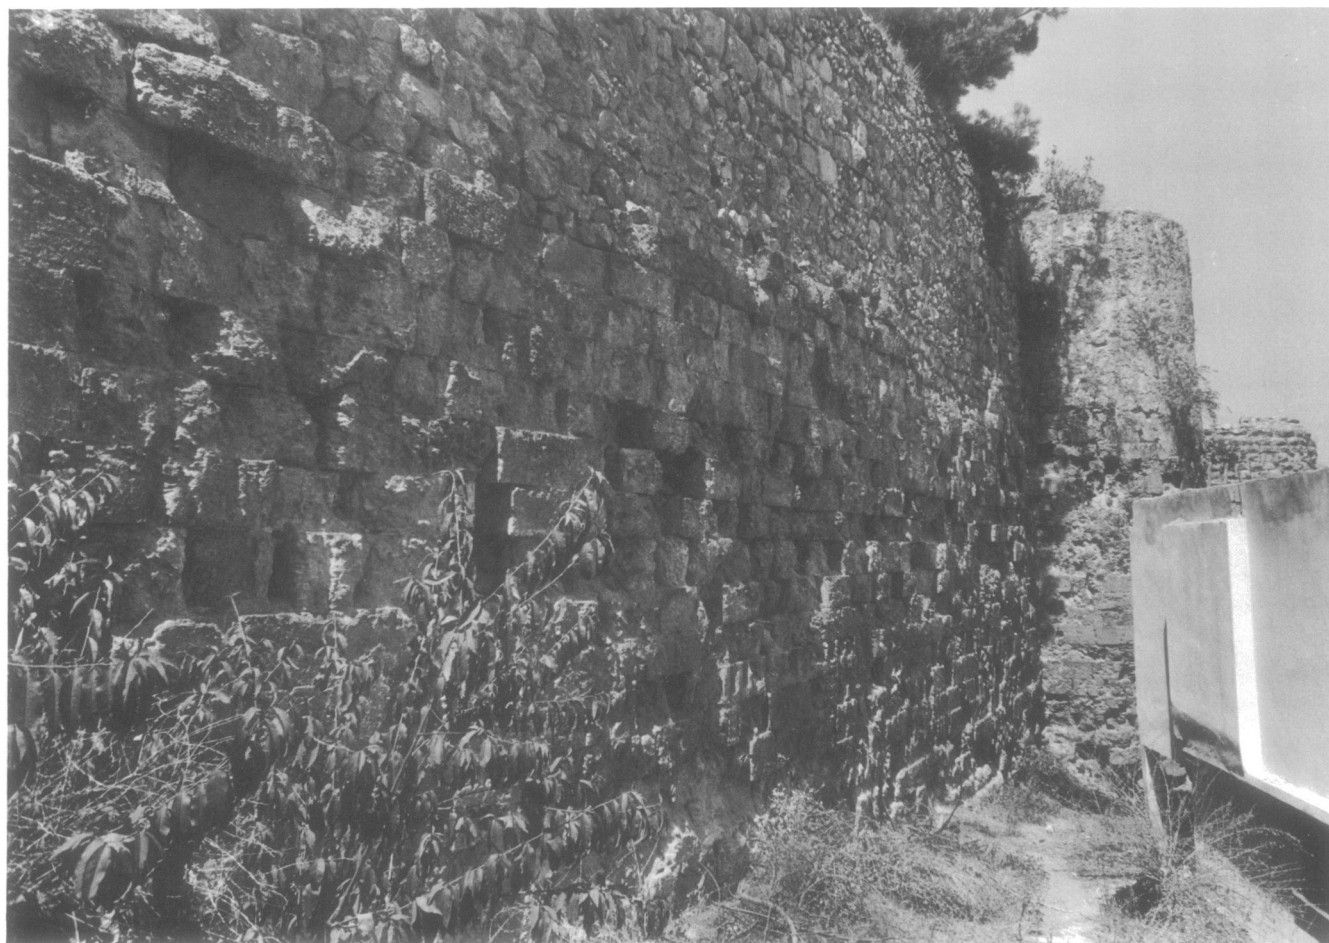
50. Tower D and Circuit of Patriarchs, Exterior, looking Northwest

Directly west of the donjon are two medieval (?) revetment walls which support an upper terrace. The lower of the two walls, which is deteriorating rapidly, is 15 m. in length and undoubtedly connected with a section 20 m. to the south. The lower wall actually supports the east flank of a narrow road that runs below salient C (fig. 49). The road skirts the base of the upper revetment wall attached to C and today is used by the custodians of the reservoir. The upper revetment, which is the westernmost of the two walls, is actually anchored on a foundation of rock and displays many building periods. A 12-m. section directly south of salient C (fig. 49) is composed of the rusticated blocks so typical of medieval Armenian architecture (figs. 47–48). A fine vertical seam separates this section from the southern continuation of the wall which consists of field stones bound in a thick matrix of mortar. Directly north of salient C the walls are made of relatively smooth well-cut ashlar blocks which are framed by wide beds of mortar. There is a thin horizontal chase almost midway in the face of this wall. Like similar features in the apartments at Çandır and the chapel at Kız (near Gösne) the chase is almost as deep as the facing stones and probably held a wooden beam. The wood may have been decorated but its real function was to give some elasticity to the walls during an earthquake. Salient C was actually added at a later building period because its rough ashlar blocks, which do *not* have prominent margins of mortar, overlap the rusticated stones and are not anchored to the wall face. It seems likely that all four types of masonry in the upper revetment wall represent different periods of construction. Since the ashlar in tower C and the crude field stones of the southern extension resemble the masonry near tower D (cf. fig. 50), they may belong to the eighteenth and nineteenth centuries.

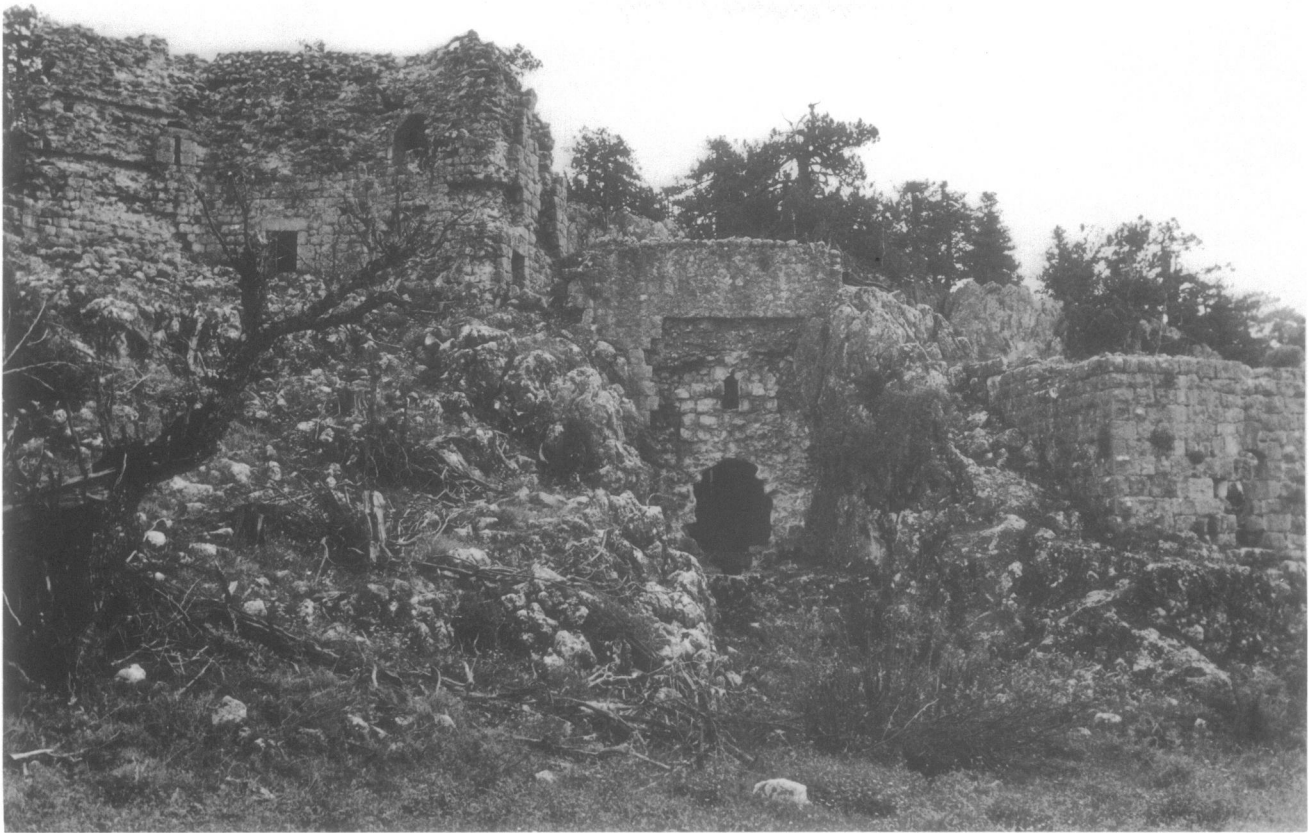
75. Tamrut, Chapel (center), Exterior, looking Southeast

Unfortunately, none of the tower-chapels in Armenian Cilicia has a complete roof to show how (or if) the traditional gable was replaced at the east by a crenellated parapet.³⁰ Tamrut's chapel, which is not actually a protruding salient, has a flat platform built across the top of the nave and apse (fig. 75).
